Flight Information File 2009-05

SUBJECT: Analysis of an Aircraft Incident

DATE: September 24, 2009

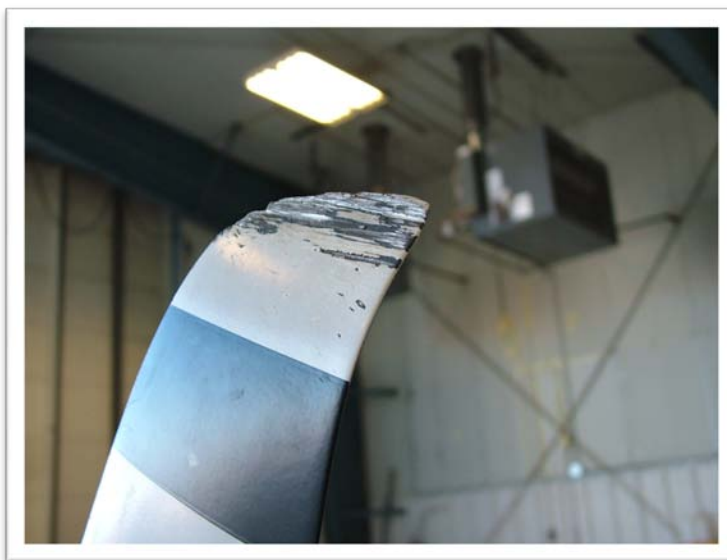
Figure 1

Maintenance technicians discovered what is an all too common outcome to a bad landing. All three propeller blades had struck the runway and were bent back [Figure 1]. One propeller blade showed evidence that it struck the nose wheel fairing. The nose wheel landing gear pucks, designed to absorb most of the landing forces, were crushed and even pushed back to the point where they impacted and caved in the oil filter [Figure 2]. The initial estimate from maintenance is that this will cost approximately \$30,000.00 to repair the aircraft and that it may be out of service for two to three weeks.

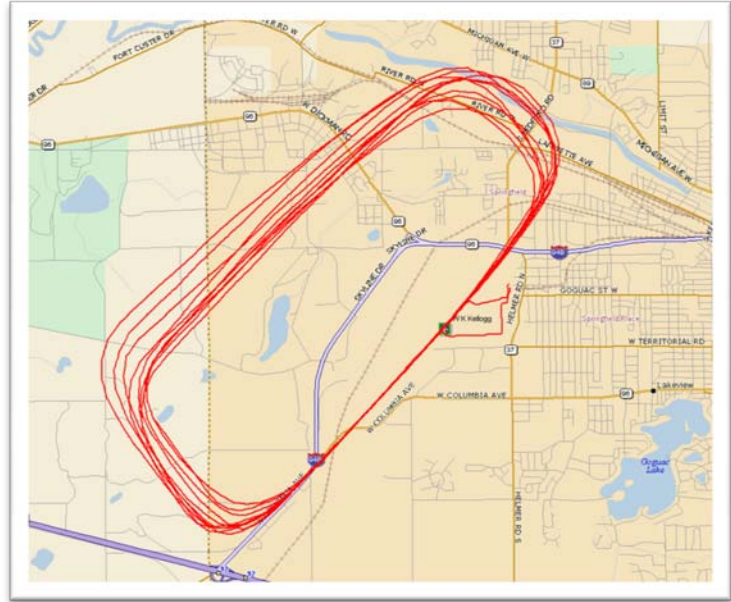
Figure 3

Following a debrief with the pilot, the next action was to examine the data from the aircraft's MFD. A unique feature of Cirrus aircraft is that the MFD records certain parameters every six seconds of operation. This is exceptionally useful to help recreate a flight when needed. In this particular situation, the MFD data did not shed any light beyond the pilot's account. It did however show that the pilot was very consistent in his traffic patterns [Figure 3].
