Eighteenth Century Architectural Hardware

Found at Fort St. Joseph

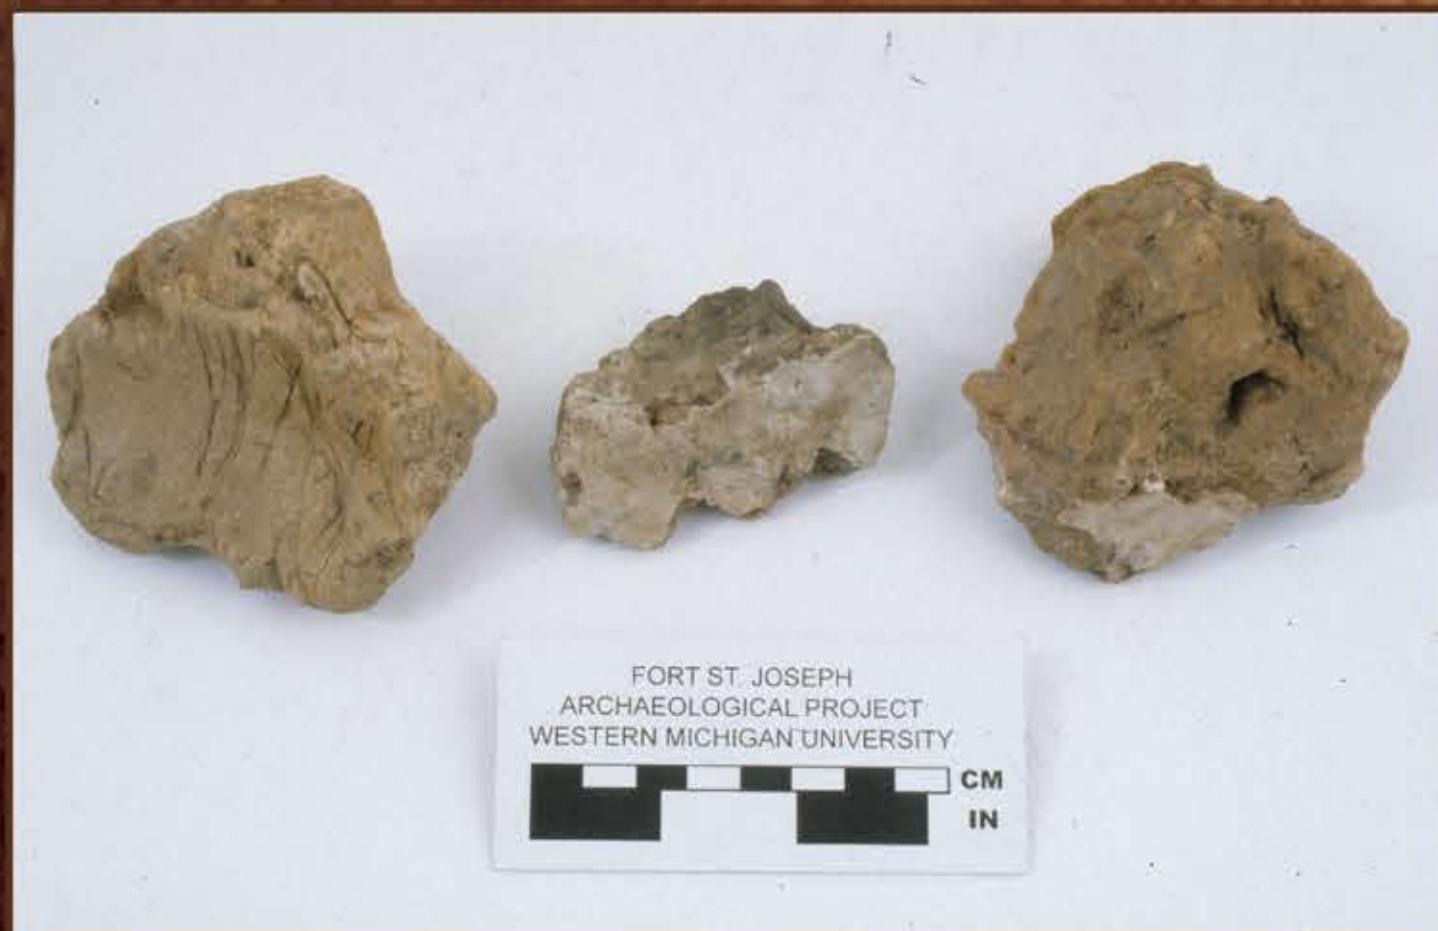
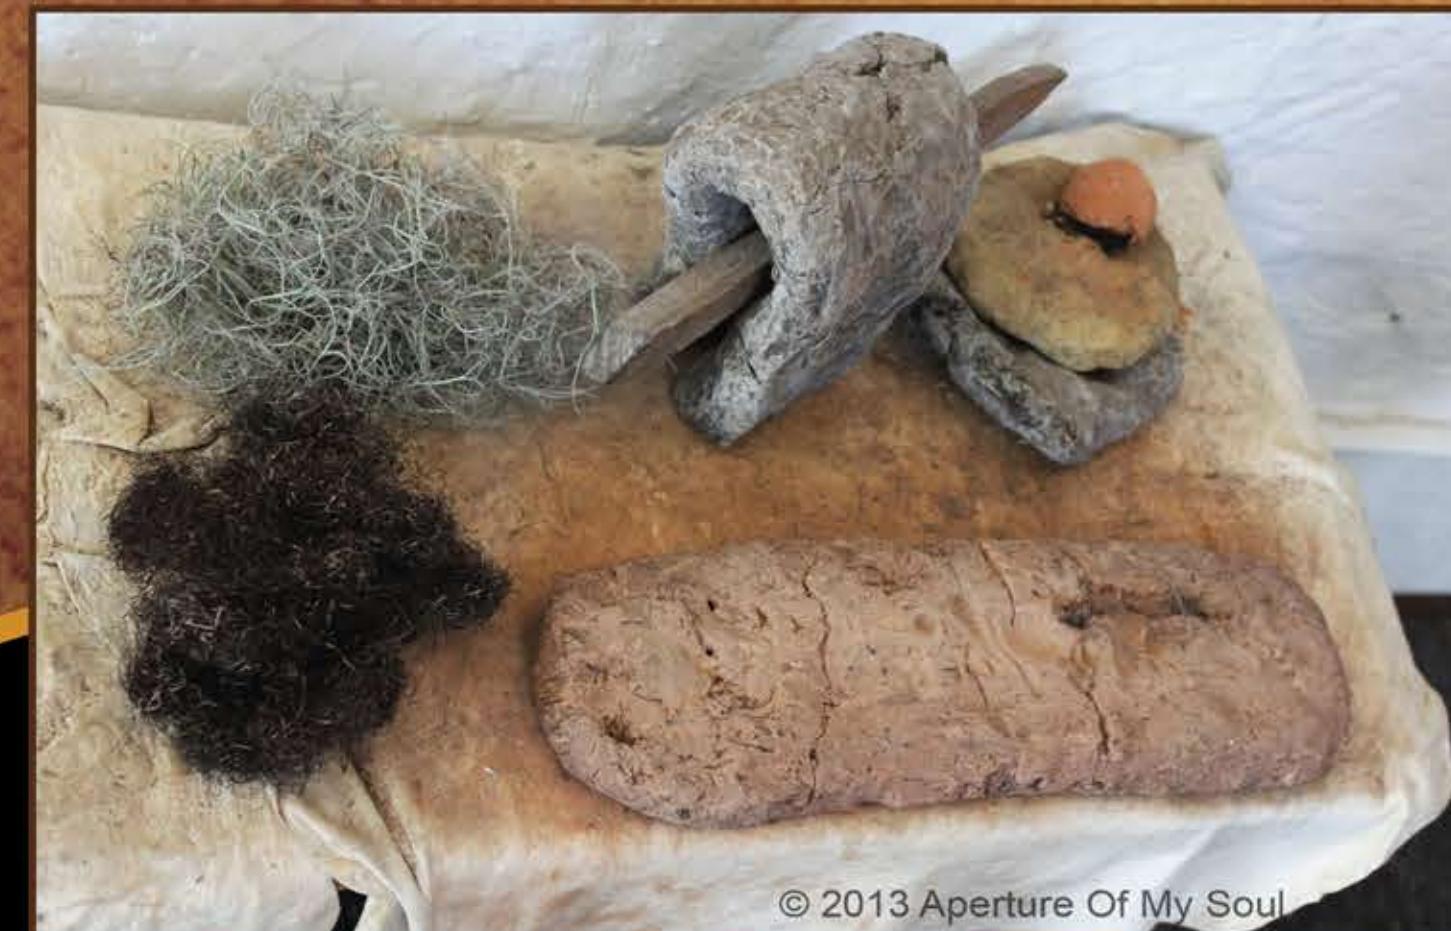
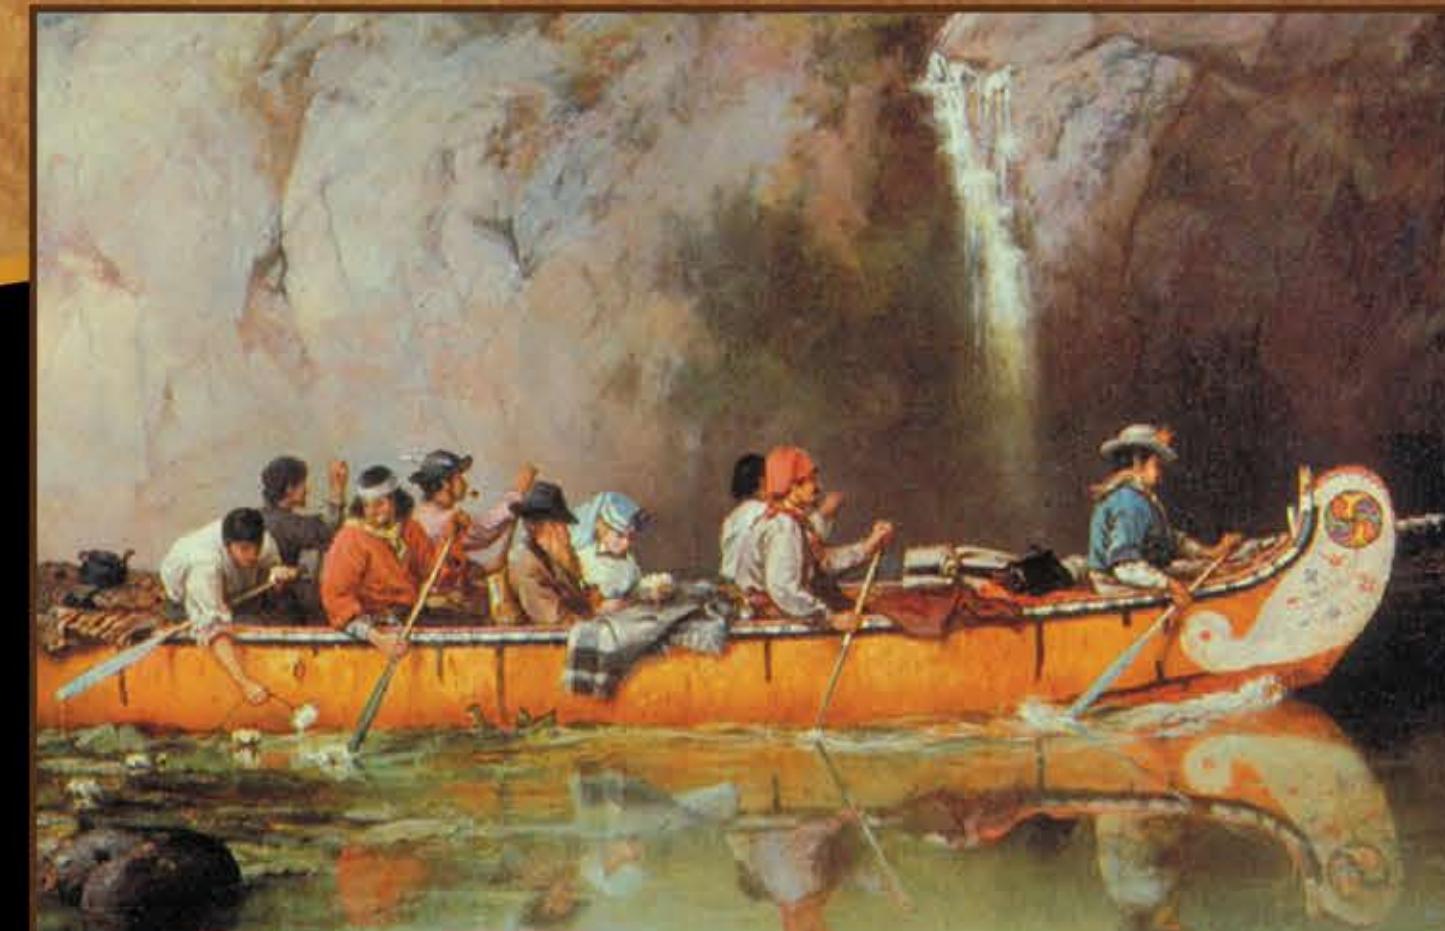
Bousillage found at Fort St. Joseph (image on left) was made with clay and straw (image on right)

The French settlers in the region built their homes using familiar techniques. Their houses consisted largely of wooden posts that were stuck in the ground or placed on stone foundations. The spaces between the posts were filled with stone and mortar (*pierrotage*), and a mixture of clay and straw (*bousillage*), to construct the walls. Traces of this mixture have been found at Fort St. Joseph.

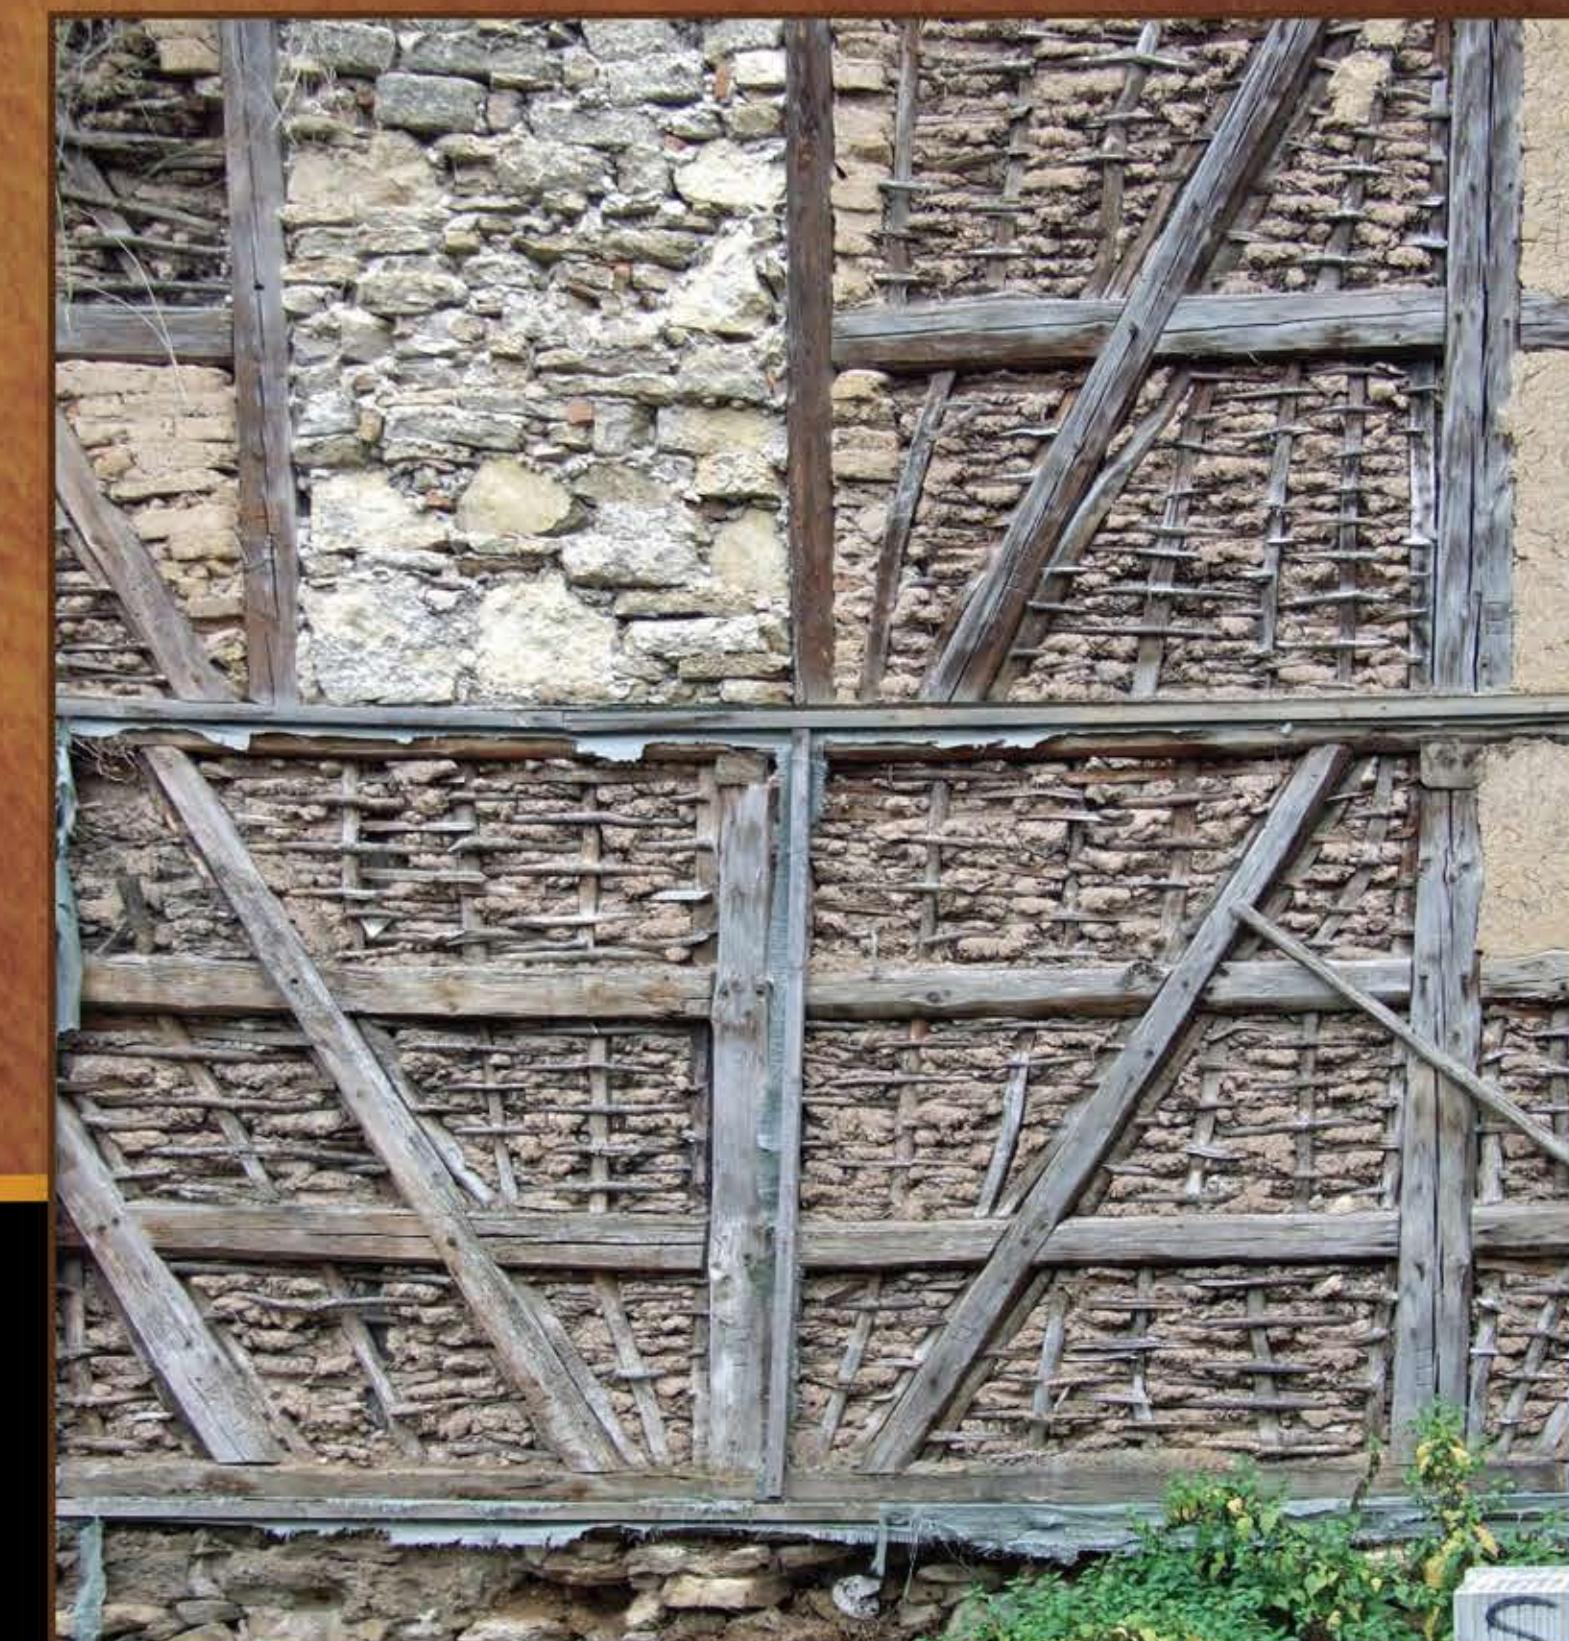
The mixture of stone and mortar used to fill the spaces in the wooden posts of walls is called *pierrotage*.

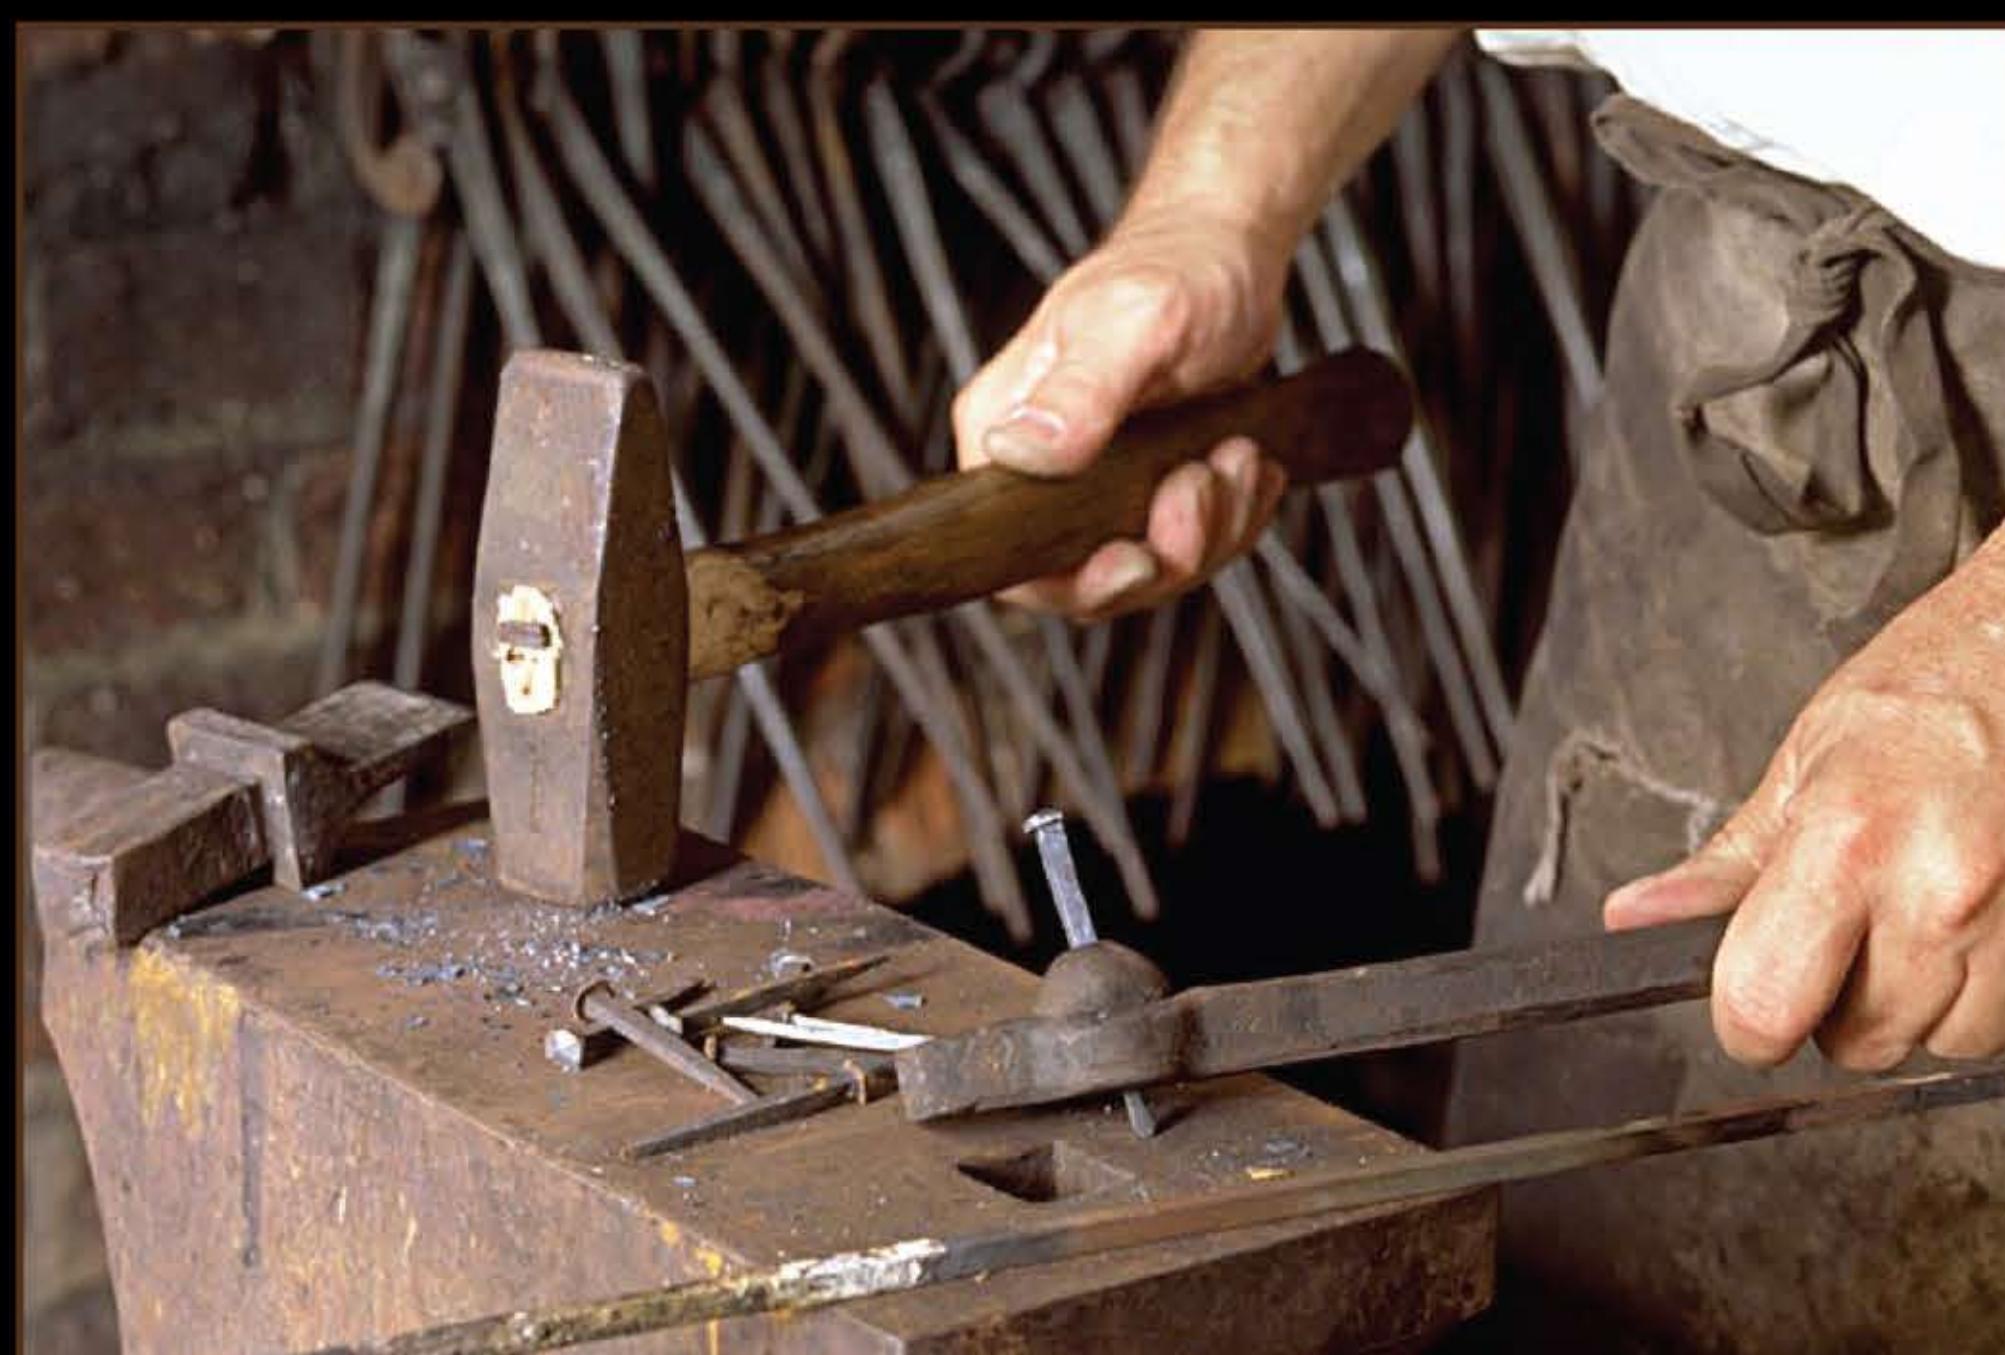
Nails made by a blacksmith are four sided and taper toward the tip.

The large numbers of hand-wrought iron nails and other metal hardware recovered from the site indicates the widespread use of metal in architecture at Fort St. Joseph.

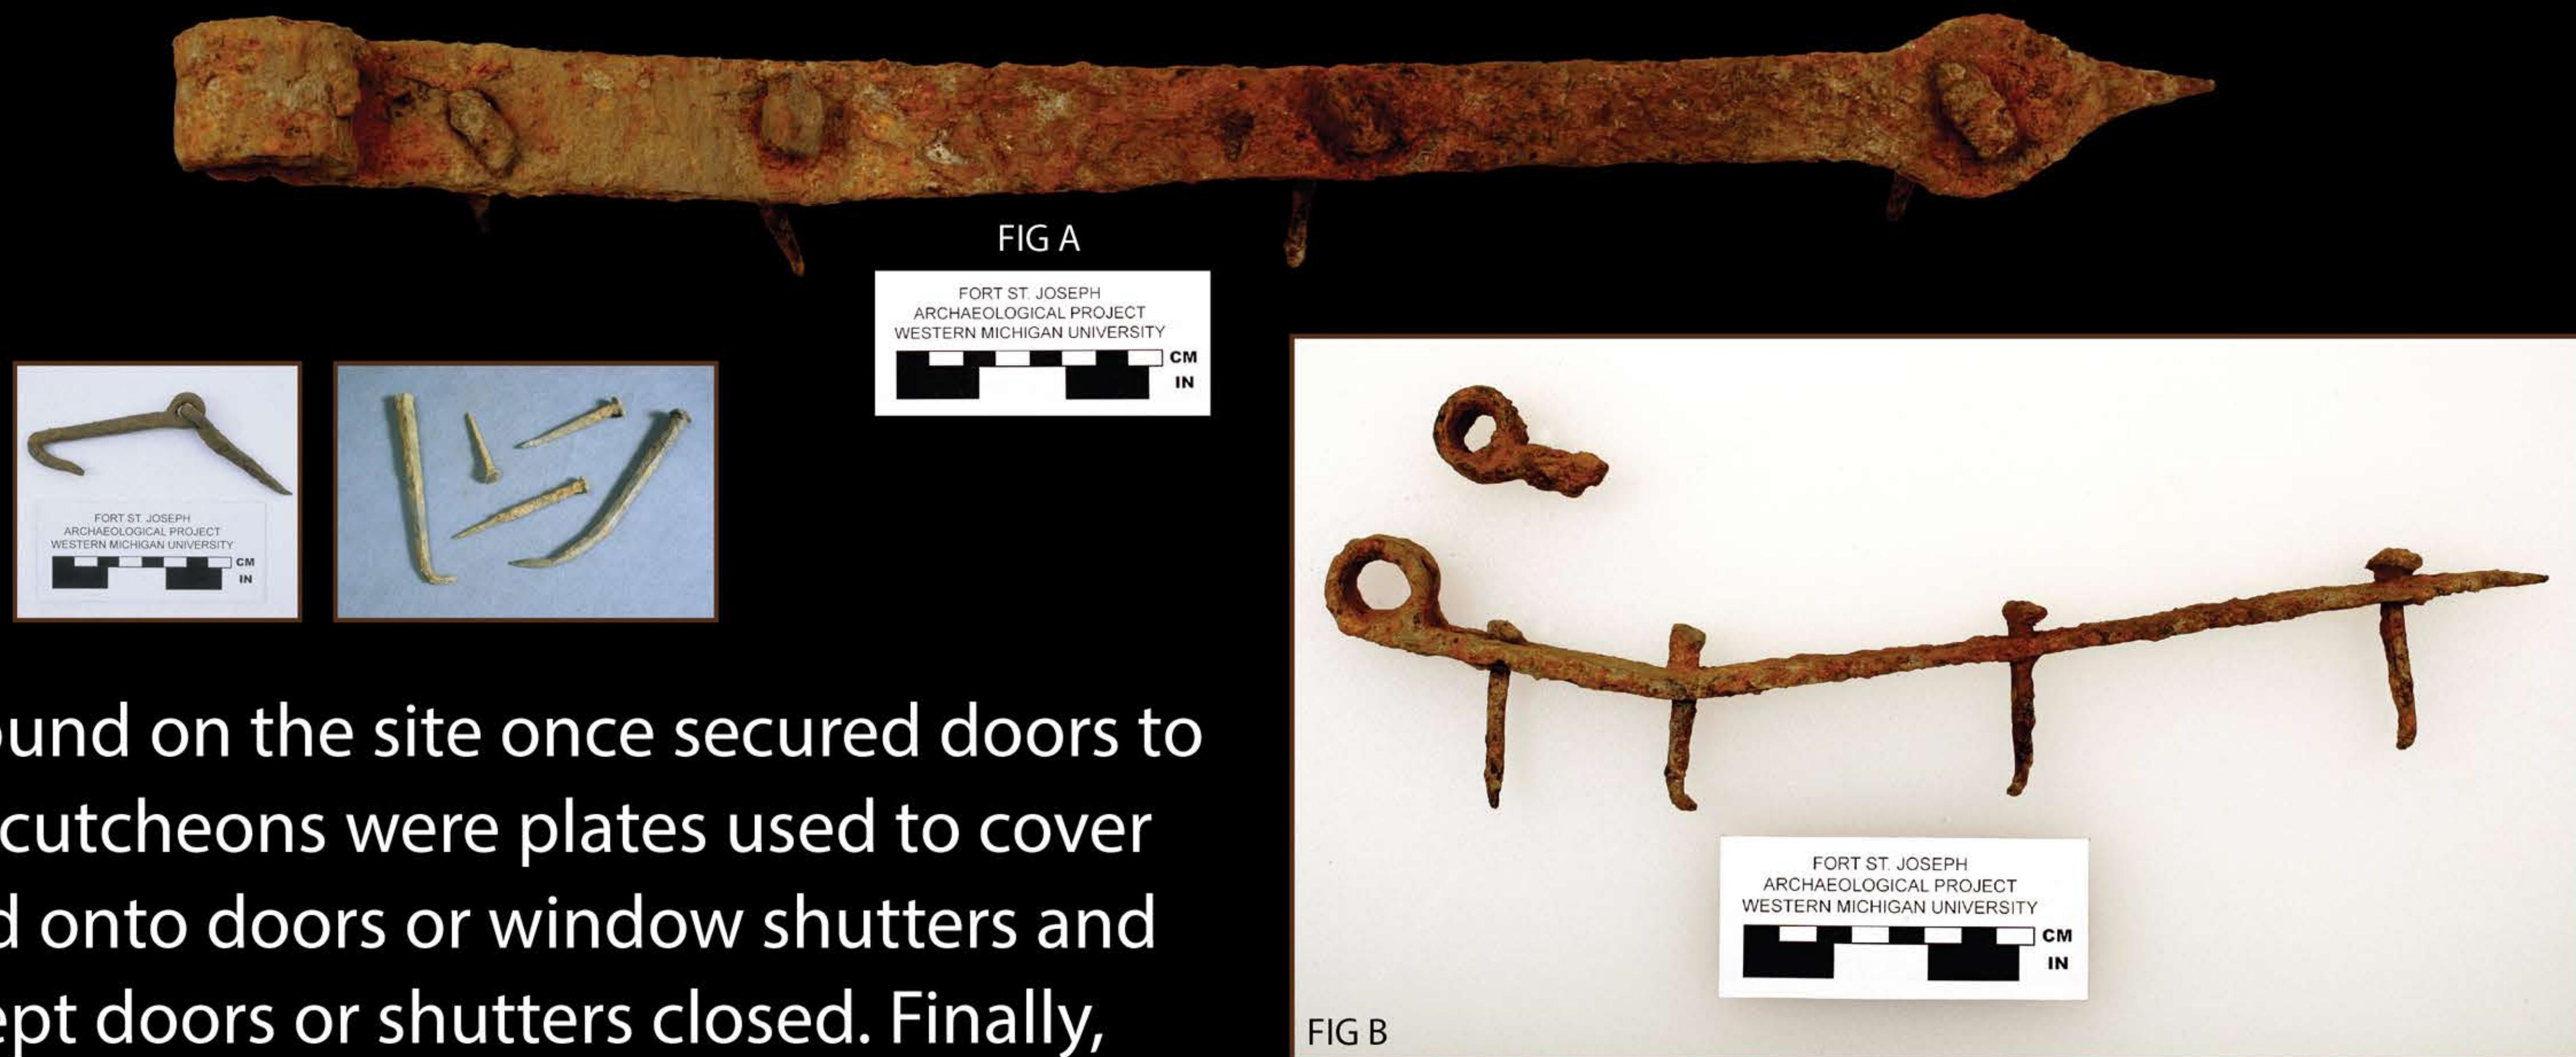
FIG A and B: Top and side views of a door hinge recovered at Fort St. Joseph. The fort's resident blacksmith probably made the nails used to fasten the hinge to the door.

Besides nails, door hinges and pintles found on the site once secured doors to frames so they could open and close. Escutcheons were plates used to cover keyholes. Hook and eye latches fastened onto doors or window shutters and latched onto metal rings in the frame kept doors or shutters closed. Finally, door latch catches were fastened to frames so that the latch bar of the door stayed shut.
